## ‘Eua survey report<sup>1</sup>

### 1. Sedimentation survey out of ‘Eua Harbor (23 July 2002)

## 2. Spot check (24 July 2002)

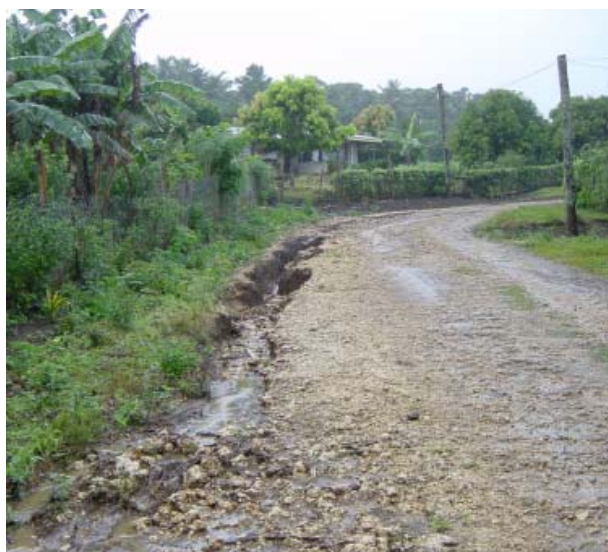
Figure 1. ‘Eua’s roads with steep slope where erosion is often observed

People in ‘Eua have environmental concerns including soil run-off from farms, logging sites and roads onto coastal waters through streams (Figures 1 and 2). A stream running into ‘Eua Harbor is one of the main river systems in ‘Eua and is likely to carry sediment into waters more than any other streams in ‘Eua. To evaluate sedimentation on the coral reefs, we observed the sea floor outside of the harbor, where the chance of detecting sedimentation is likely to be the highest in ‘Eua.

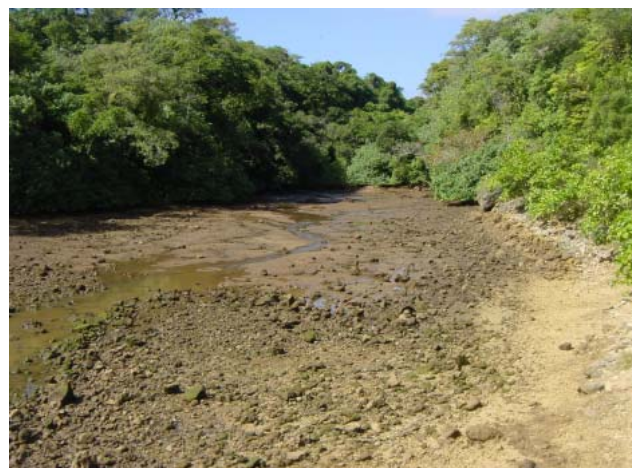
Figure 2. Sedimentation on the river floor adjacent to ‘Eua Harbor

In spite of the muddy water of the stream running into the harbor indicating heavy soil run-off from upper areas, the waters surrounding the harbor showed high transparency (Figures 1, 2 and 4). There was no notable effect of sedimentation at the point we dived (Figure 4). Sediment from stream is likely to be flashed away by current, once it goes out of the harbor. Observation of the reef flats surrounding the harbor also suggests that there is no notable effect of sedimentation (Figure 5). Despite this, as soil run-off is obvious in 'Eua, it may be recommended to monitor sedimentation around the mouth of stream<sup>5</sup>.

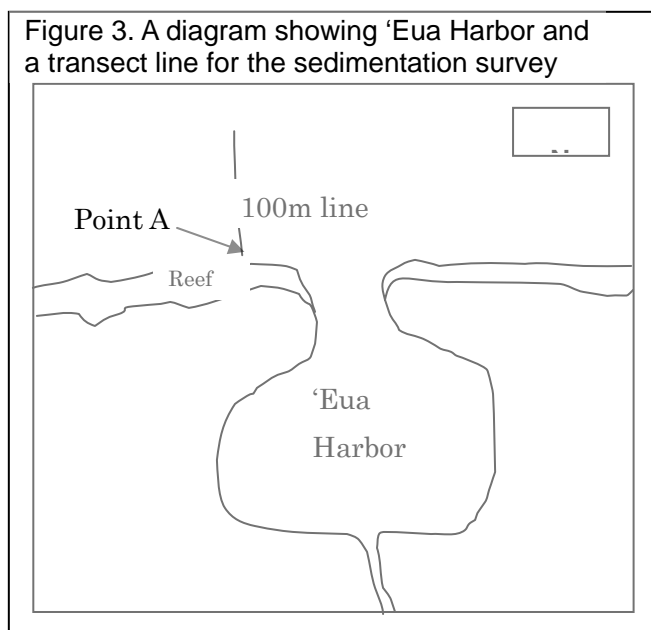
From a point near entrance of the harbor, a SCUBA diver laid a 100m transect line perpendicular to the coast line (Figure 3). The diver swam from the deepest point (end of the line) towards the coast (beginning of the line) and estimated live hard coral cover (%), dead hard coral cover, soft coral cover, every 10m (with the width of 10m). The diver observed the sedimentation on the substrata (Rank: 0, none; 1, little; 2, some; 3, a lot).

From Point A (Fig. 3) in the shallow (2m) area near the entrance of the harbor to about 70m off with depth of 10m, the coverage of live hard corals, dead hard coral<sup>3</sup>, soft corals were estimated to be 25%, 25% and 5%, respectively. The dominant hard coral colonies were corymbose *Acropora*. About 95% of substratum was hard bottom, while 5% or less sandy bottom. The largest *Acropora* (corymbose) was around 100cm in diameter. In the deeper area, from 70m to 100m away from Point A (Fig. 3), where the depth is

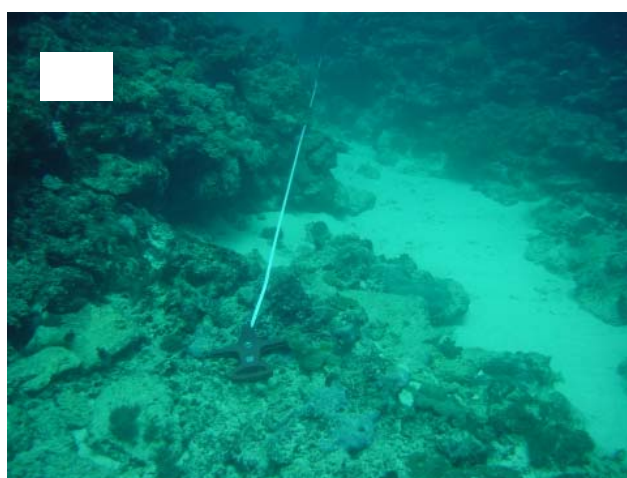
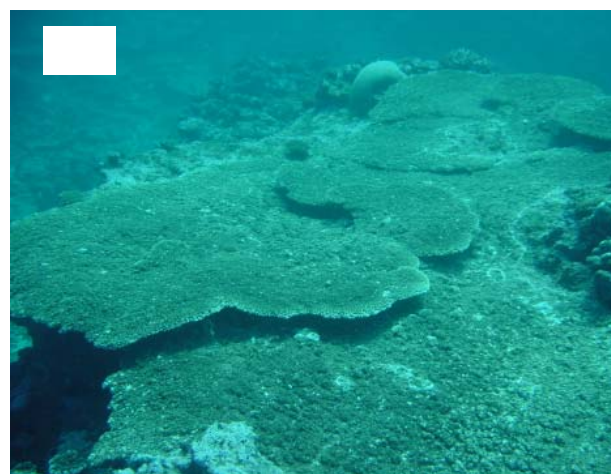
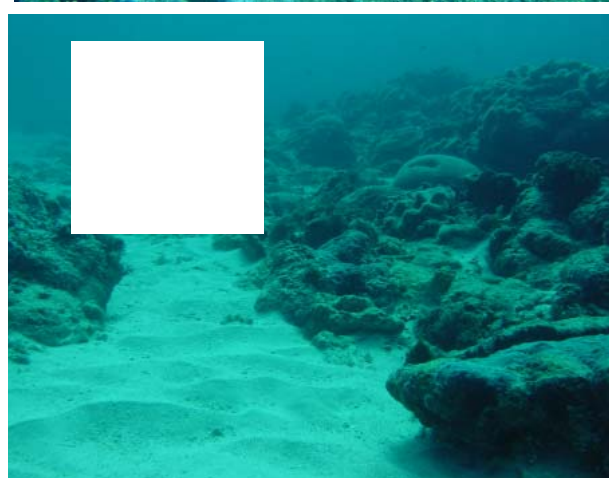
about 20m, the percentage covers of live hard corals, dead hard coral, soft corals were estimated to be 5%, 5% and 5%, respectively, with dominant massive and encrusting hard corals. Large colonies, with about 5m in diameter, of tabular *Acropora* were observed (Figure 4). Five to 10% of the substratum is sandy bottom, which increases as depth becomes greater (20% at 20m deep). Very small surface was covered by sand (<5%). No sign of sedimentation was observed along the line<sup>4</sup> (Figure 5).

Figure 4. A) Large (>5m diameter) tabular *Acropora* near the entrance of 'Eua Harbor. B) and C) 100m away from the entrance of the harbor with the depth of about 20m. No symptom of sedimentation was observed.

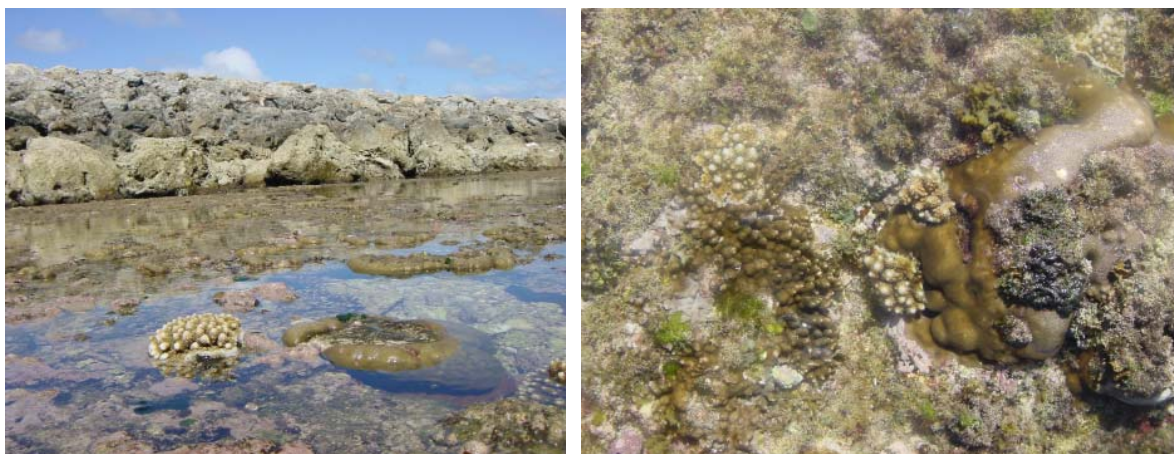
Figure 5. Comparatively small coral colonies on the reef flat adjacent to 'Eua Harbor

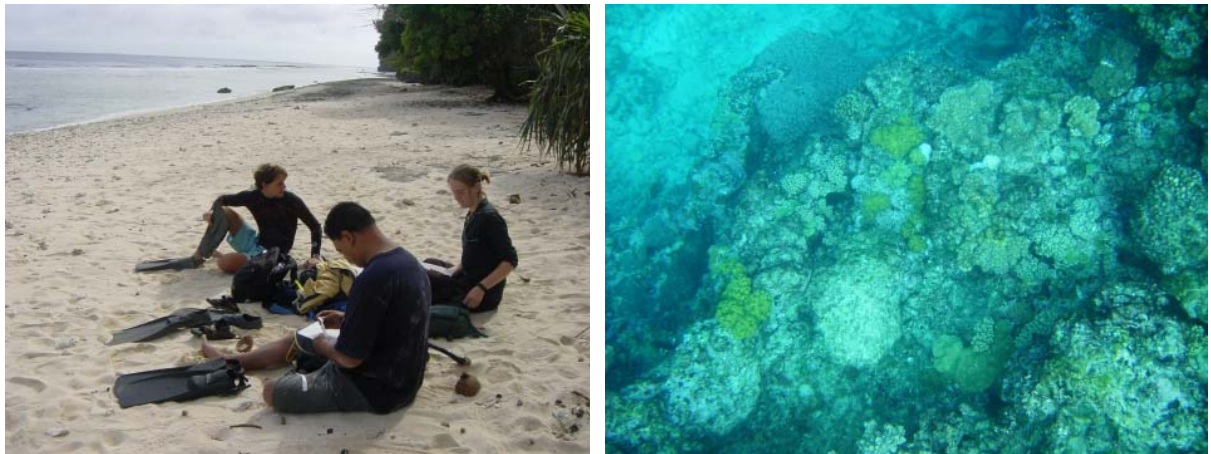
deep) was observed. Coverages of live hard coral, dead hard coral and soft coral were 5, 5 and 5%, respectively, with various live forms of coral (corymbose *Acropora* and massive *Porites* are dominant). About 10% of the bottom was covered with sand or rubble, where no live corals were observed (Figure 6). The largest tabular *Acropora* was 80cm in diameter. No sign of sedimentation was observed.

Figure 6. Scene of preparation for spot check at Loloniu Beach and a photo of outer slope

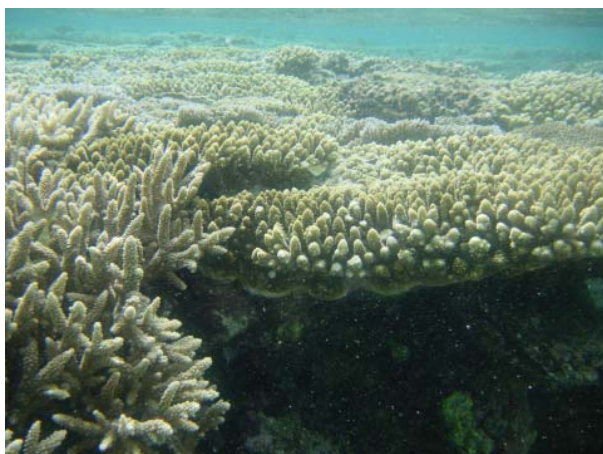
On the shallow (<1m) moat out of beautiful sandy beach, a large part of floor is occupied by patches of corals (Figure 7). On the outer slope (3 – 10m deep), coverages of live hard coral, dead hard coral and soft coral were 10, 10 and 5% respectively, with mixture of various live forms of corals with no notable dominant form. All the bottom was hard substratum without areas covered by sand or rubble. The largest tabular *Acropora* was 40cm in diameter. No sign of sedimentation was observed.

Figure 7. Healthy shallow reef at Ufilei
